Dust Action Plan and Monitoring Garden Centre Fire, London

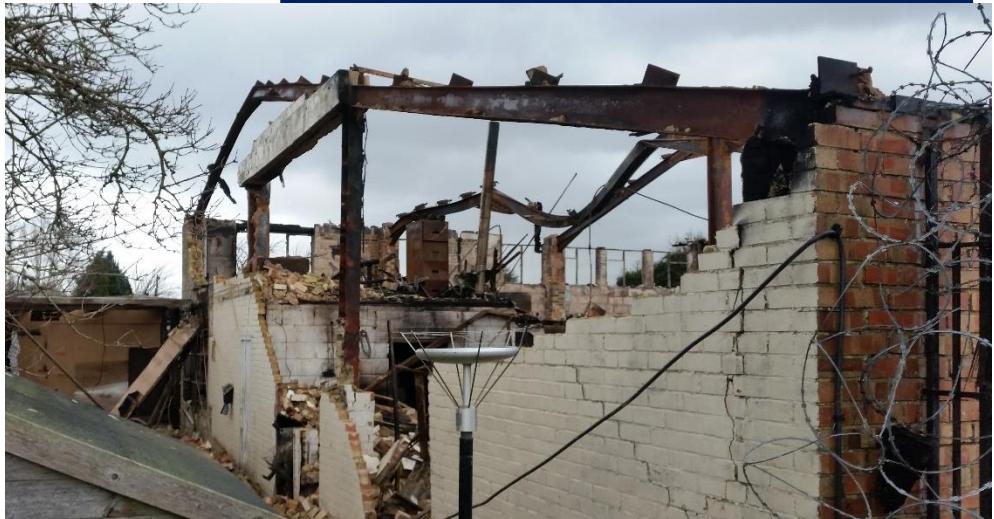
WDE Consulting Ltd (WDE) was appointed by the site owner following a large fire at a garden centre in which the build up of heat beneath an Asbestos roofing material (ACM) caused an explosion and the disintegration of the roofing materials. The garden centre needed to remain open as it was one of their busiest trading months so half the site was cordoned off with them still trading from an external area.

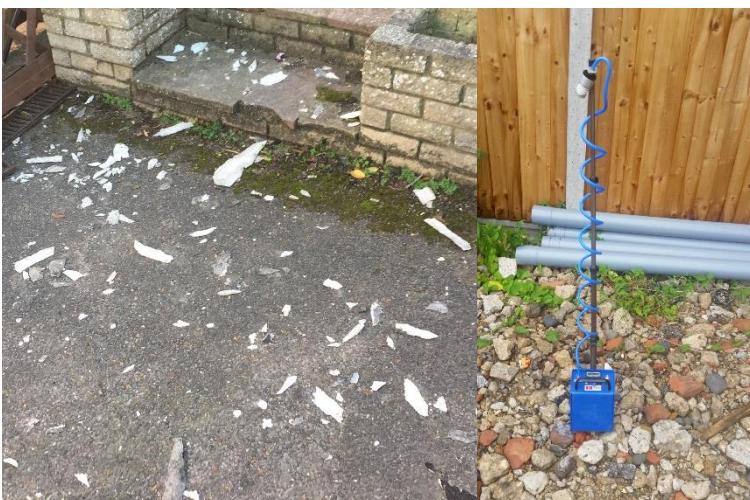
WDE was able to recommend a suitably qualified and experienced demolition contractor who could deal with the clearance of the site and complete demolition of the substantially impacted structure. WDE also completed an ACM method statement, with regulatory approval, that outlined how the contractors would remove the materials and also protect themselves/ the public whilst doing so.
